# Partially Edentulous Reconstruction

## Lower Jaw

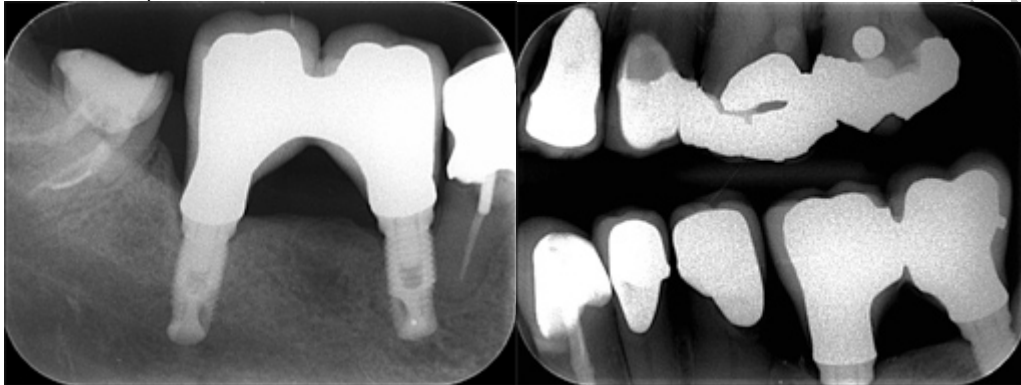
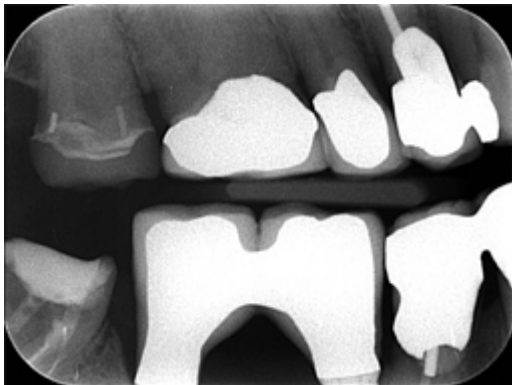
As initial x-rays show, patient has had an extensive complex restorative history, with four non-Brånemark implants placed in the posterior mandible. Patient had been happy with the existing implant outcomes and could not stand wearing a lower denture.

The sole remaining lower incisor tooth presented with an after-crown placement root canal treatment and almost no mesial interproximal bone, rendering this tooth hopeless. Previous extractions in the anterior mandible were described by the patient as surgical extractions and the x-ray shows rendered significant vertical bone damage. Initial visual presentation of the site might reasonably discuss the possibility of augmentation of this surgically damaged site, with an autogenous (own bone), block onlay bone graft.

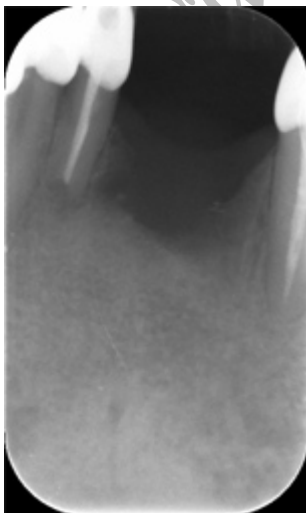
Both lower canines have VMK restorations and the left one has an after crown-placement root canal treatment, which looks sound periapically.

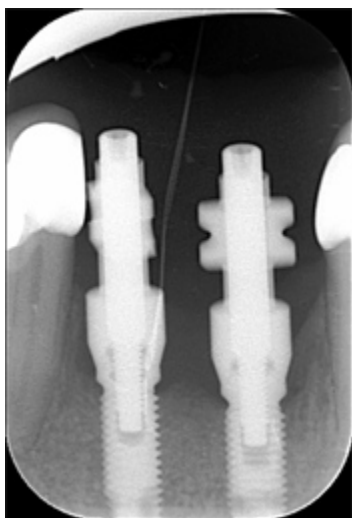
Because of the minor but residual extraction socket existing at the surgical placement, this was done as a two stage procedure with four months healing time intervening.

In this case, the left side fixture recorded 68 ISQ with a vertical probe, and 69 with the probe at right angles to the "smartpeg". The right side fixture recorded 64 and 67 respectively, ISQ units. X-ray shows bone up to throat one on both fixtures. The x-ray shows fixture level impression copings in place, with the follow-up x-ray showing two Procera custom titanium abutments tightened to 32 Ncm with the Nobel Biocare Osseocare unit.

The hopeless lower right lateral incisor was extracted in November 2004 in the same appointment as the placement of two Brånemark fixtures - 3.75mm x 13mm, Regular platform MkIII TiUnite as the right side fixture, and 3.75mm x 10mm, Regular platform standard machined fixture as the left side fixture. The right side fixture was in no way guided in placement by the residual socket of the lower right lateral incisor. The TiUnite surface was deliberately used due to its theoretical ability to attract bone synthetic cells faster. Both fixtures were machine locked at 50 Ncm insertion torque, and checked with a hand wrench. Nobel Biocare Osseoset surgical unit used for placement.

The prosthetic plan was for two fixtures and two custom Procera titanium abutments to support a four unit VMK (porcelain bonded to gold crowns) bridge, thereby replacing all four lower incisors.

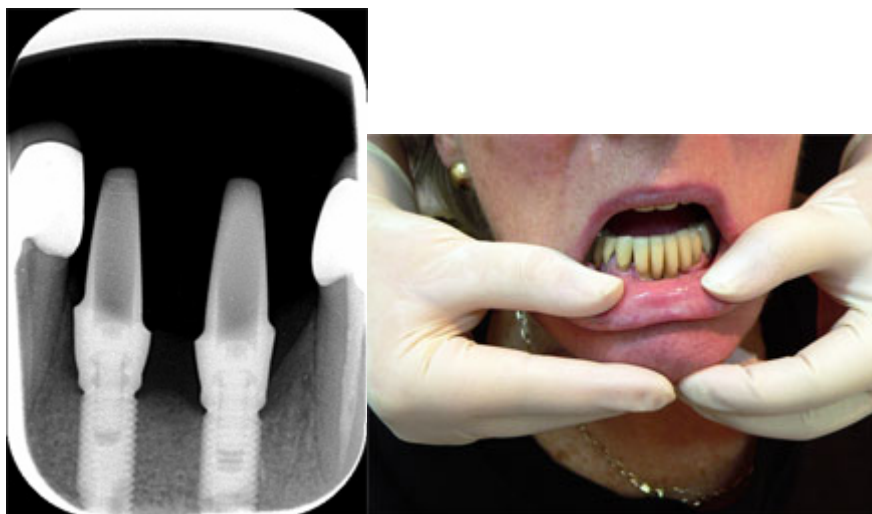
Photograph shows the extent of the vertical bone damage relative to the gingival margin positioning of the bridge restoration. We took the Swedish approach which was to place the fixtures in primary bone, if sufficient primary bone is available, and thereby retain the over ninety-nine percent success rate in the anterior mandible. A block onlay bone graft may have enhanced the aesthetic gingival or gum line position, but risked a failure rate of up to twenty percent, usually resulting in further devastation to the site, if it failed, and risking implant failure rates in graft bone of fifteen to twenty percent also.

The lip line held in the photograph is an obvious exaggeration of normal lip posture, purely to demonstrate how low the gingival bridge margin is.

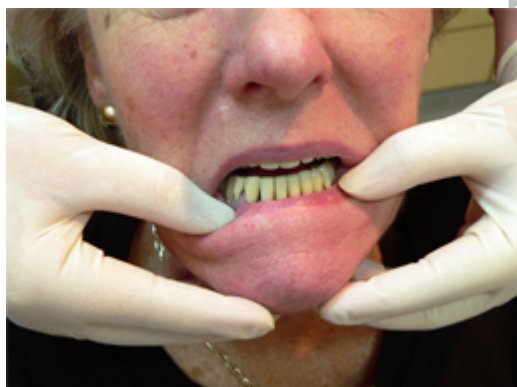
The second photograph is I believe, close to a maximum display of lower incisor teeth within the range of normal lip posture and more than satisfies any cosmetic concerns raised by the bone discrepancy.
